Operations, Maintenance, and Monitoring (OM&M) 2012 Annual Report

Ventron/Velsicol Superfund Site Operable Unit 1
Wood-Ridge and Carlstadt, New Jersey

April 15, 2013

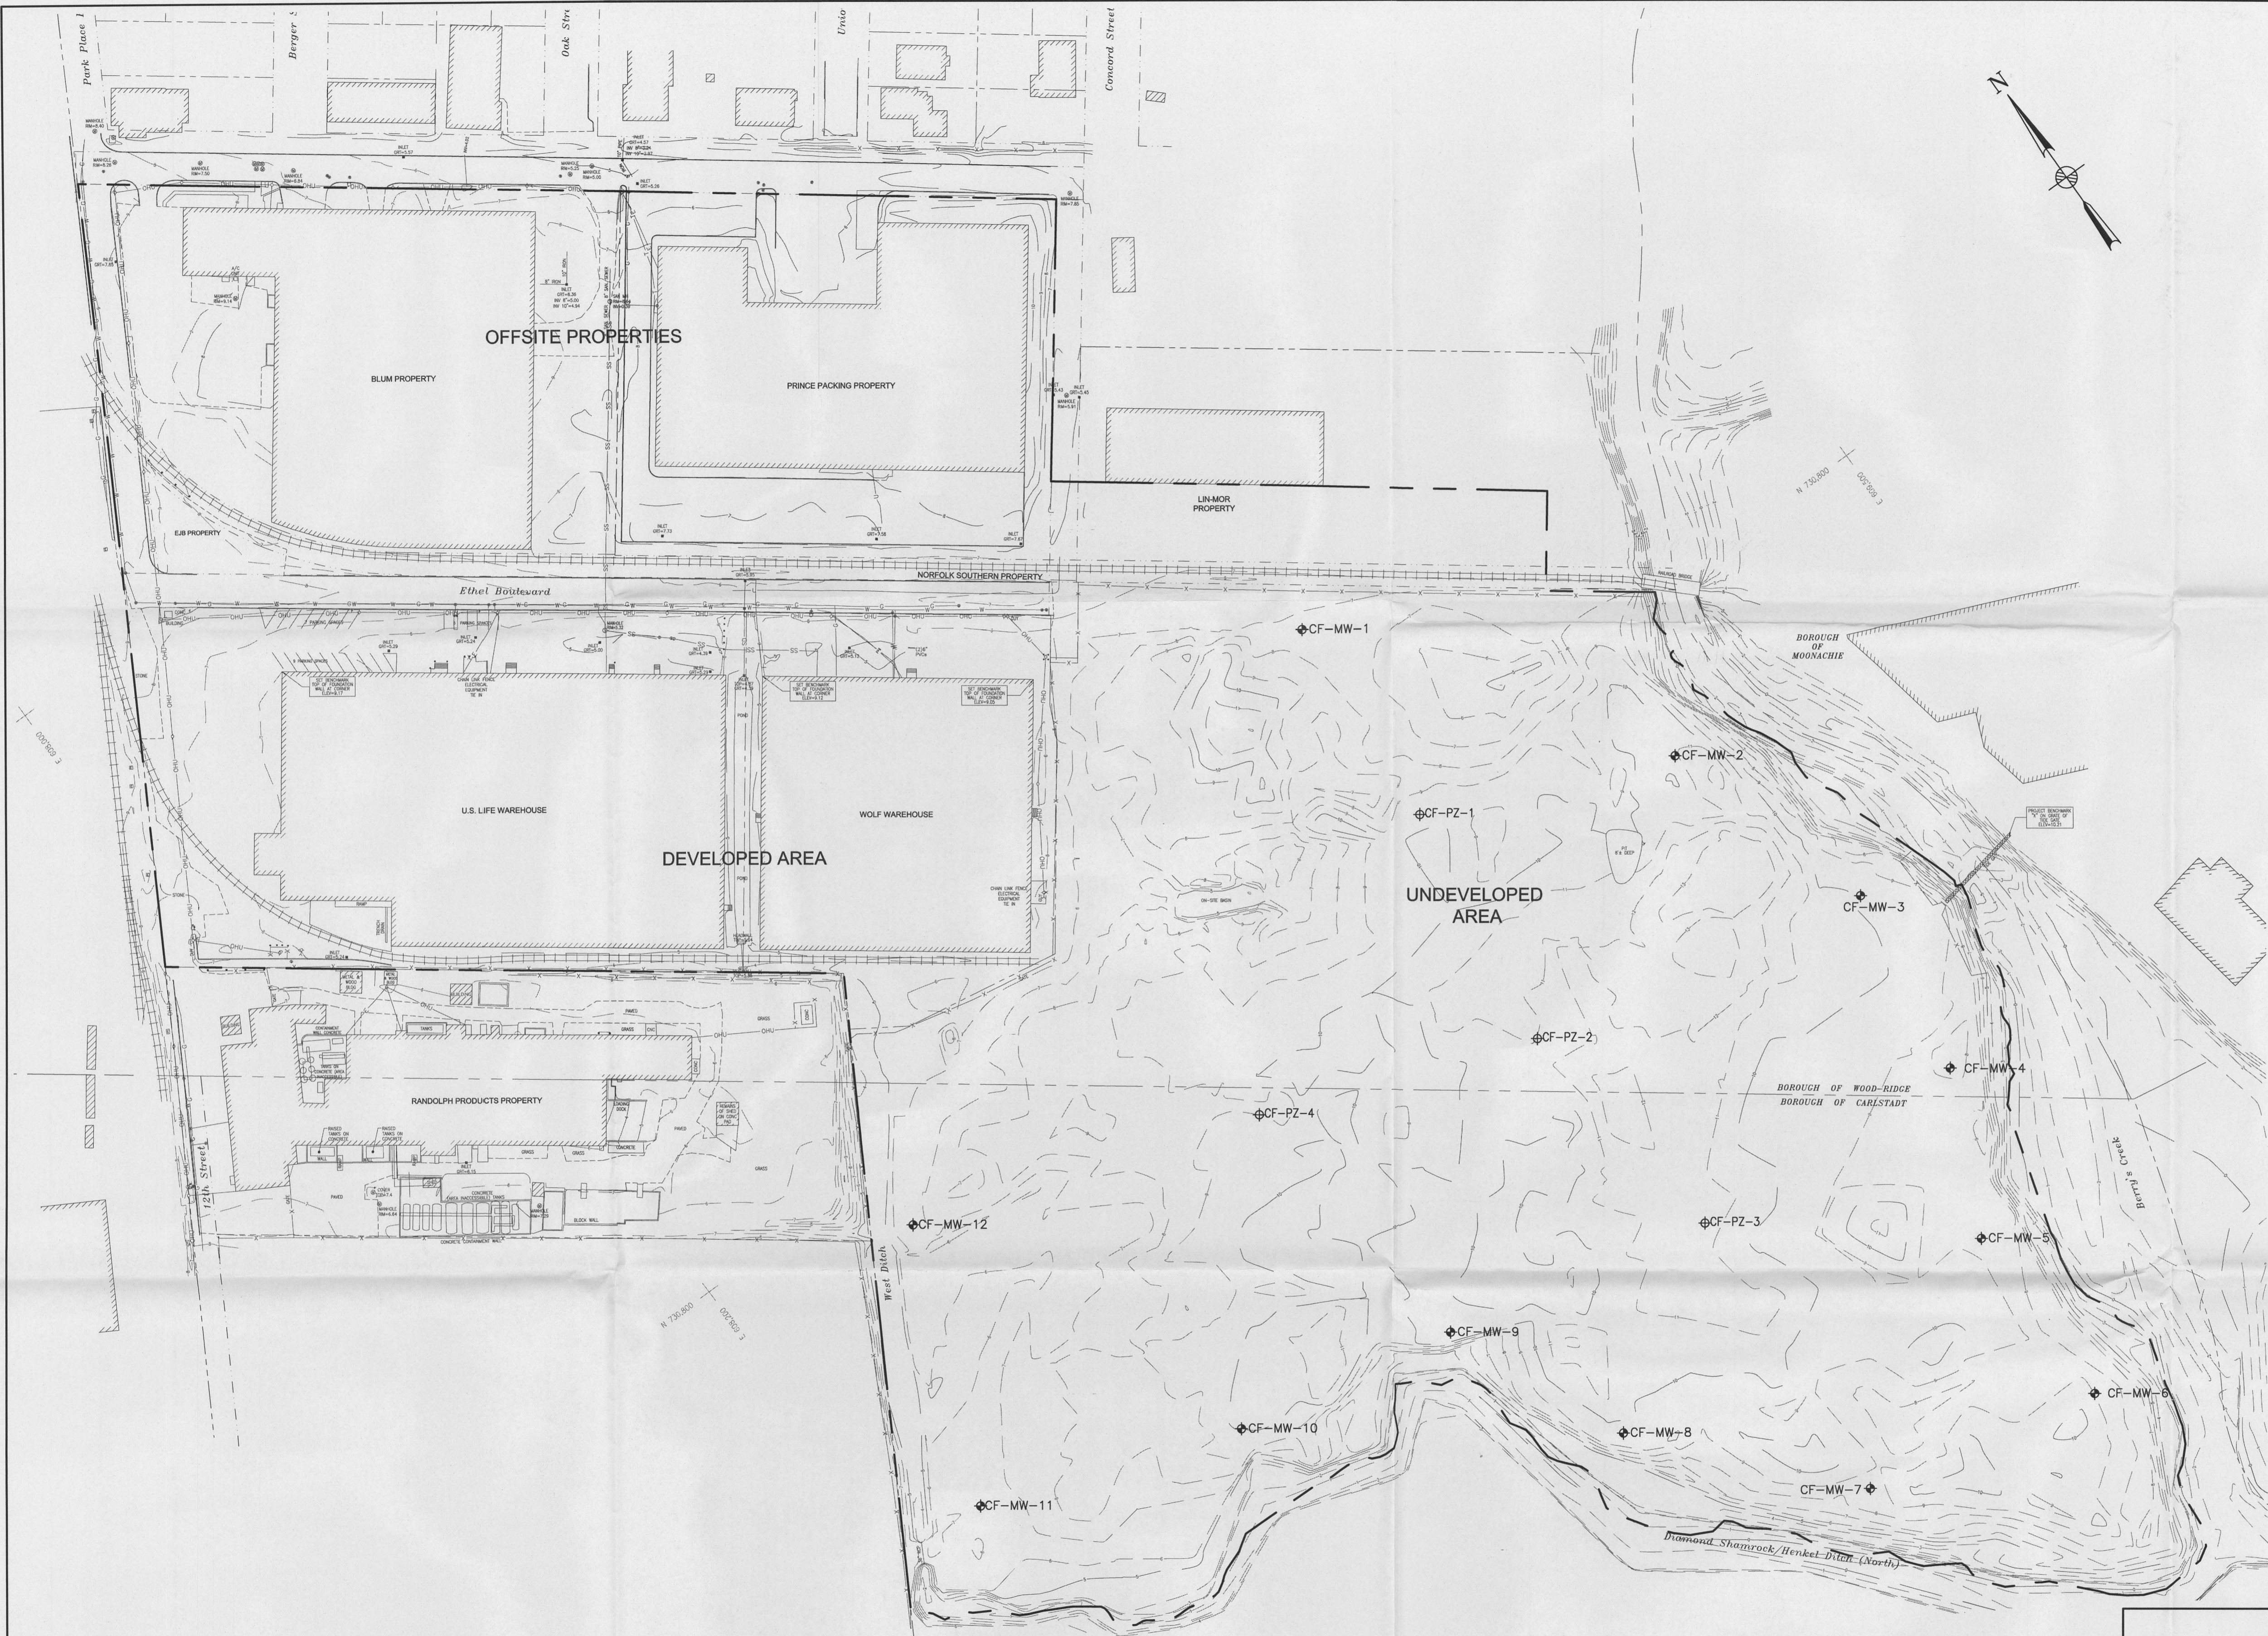
FIGURE 2

Figure 2 – Contaminant Flux Monitoring Locations

Flux Monitoring Sampling Program	
Monitoring Wells	CF-MW-1	S
	CF-MW-2	S
	CF-MW-3	S
	CF-MW-4	S
	CF-MW-5	S
	CF-MW-6	S
	CF-MW-7	S
	CF-MW-8	S
	CF-MW-9	S
	CF-MW-10	S
	CF-MW-11	S
	CF-MW-12	S
Piezometers	CF-PZ-1	WL
	CF-PZ-2	WL
	CF-PZ-3	WL
	CF-PZ-4	WL

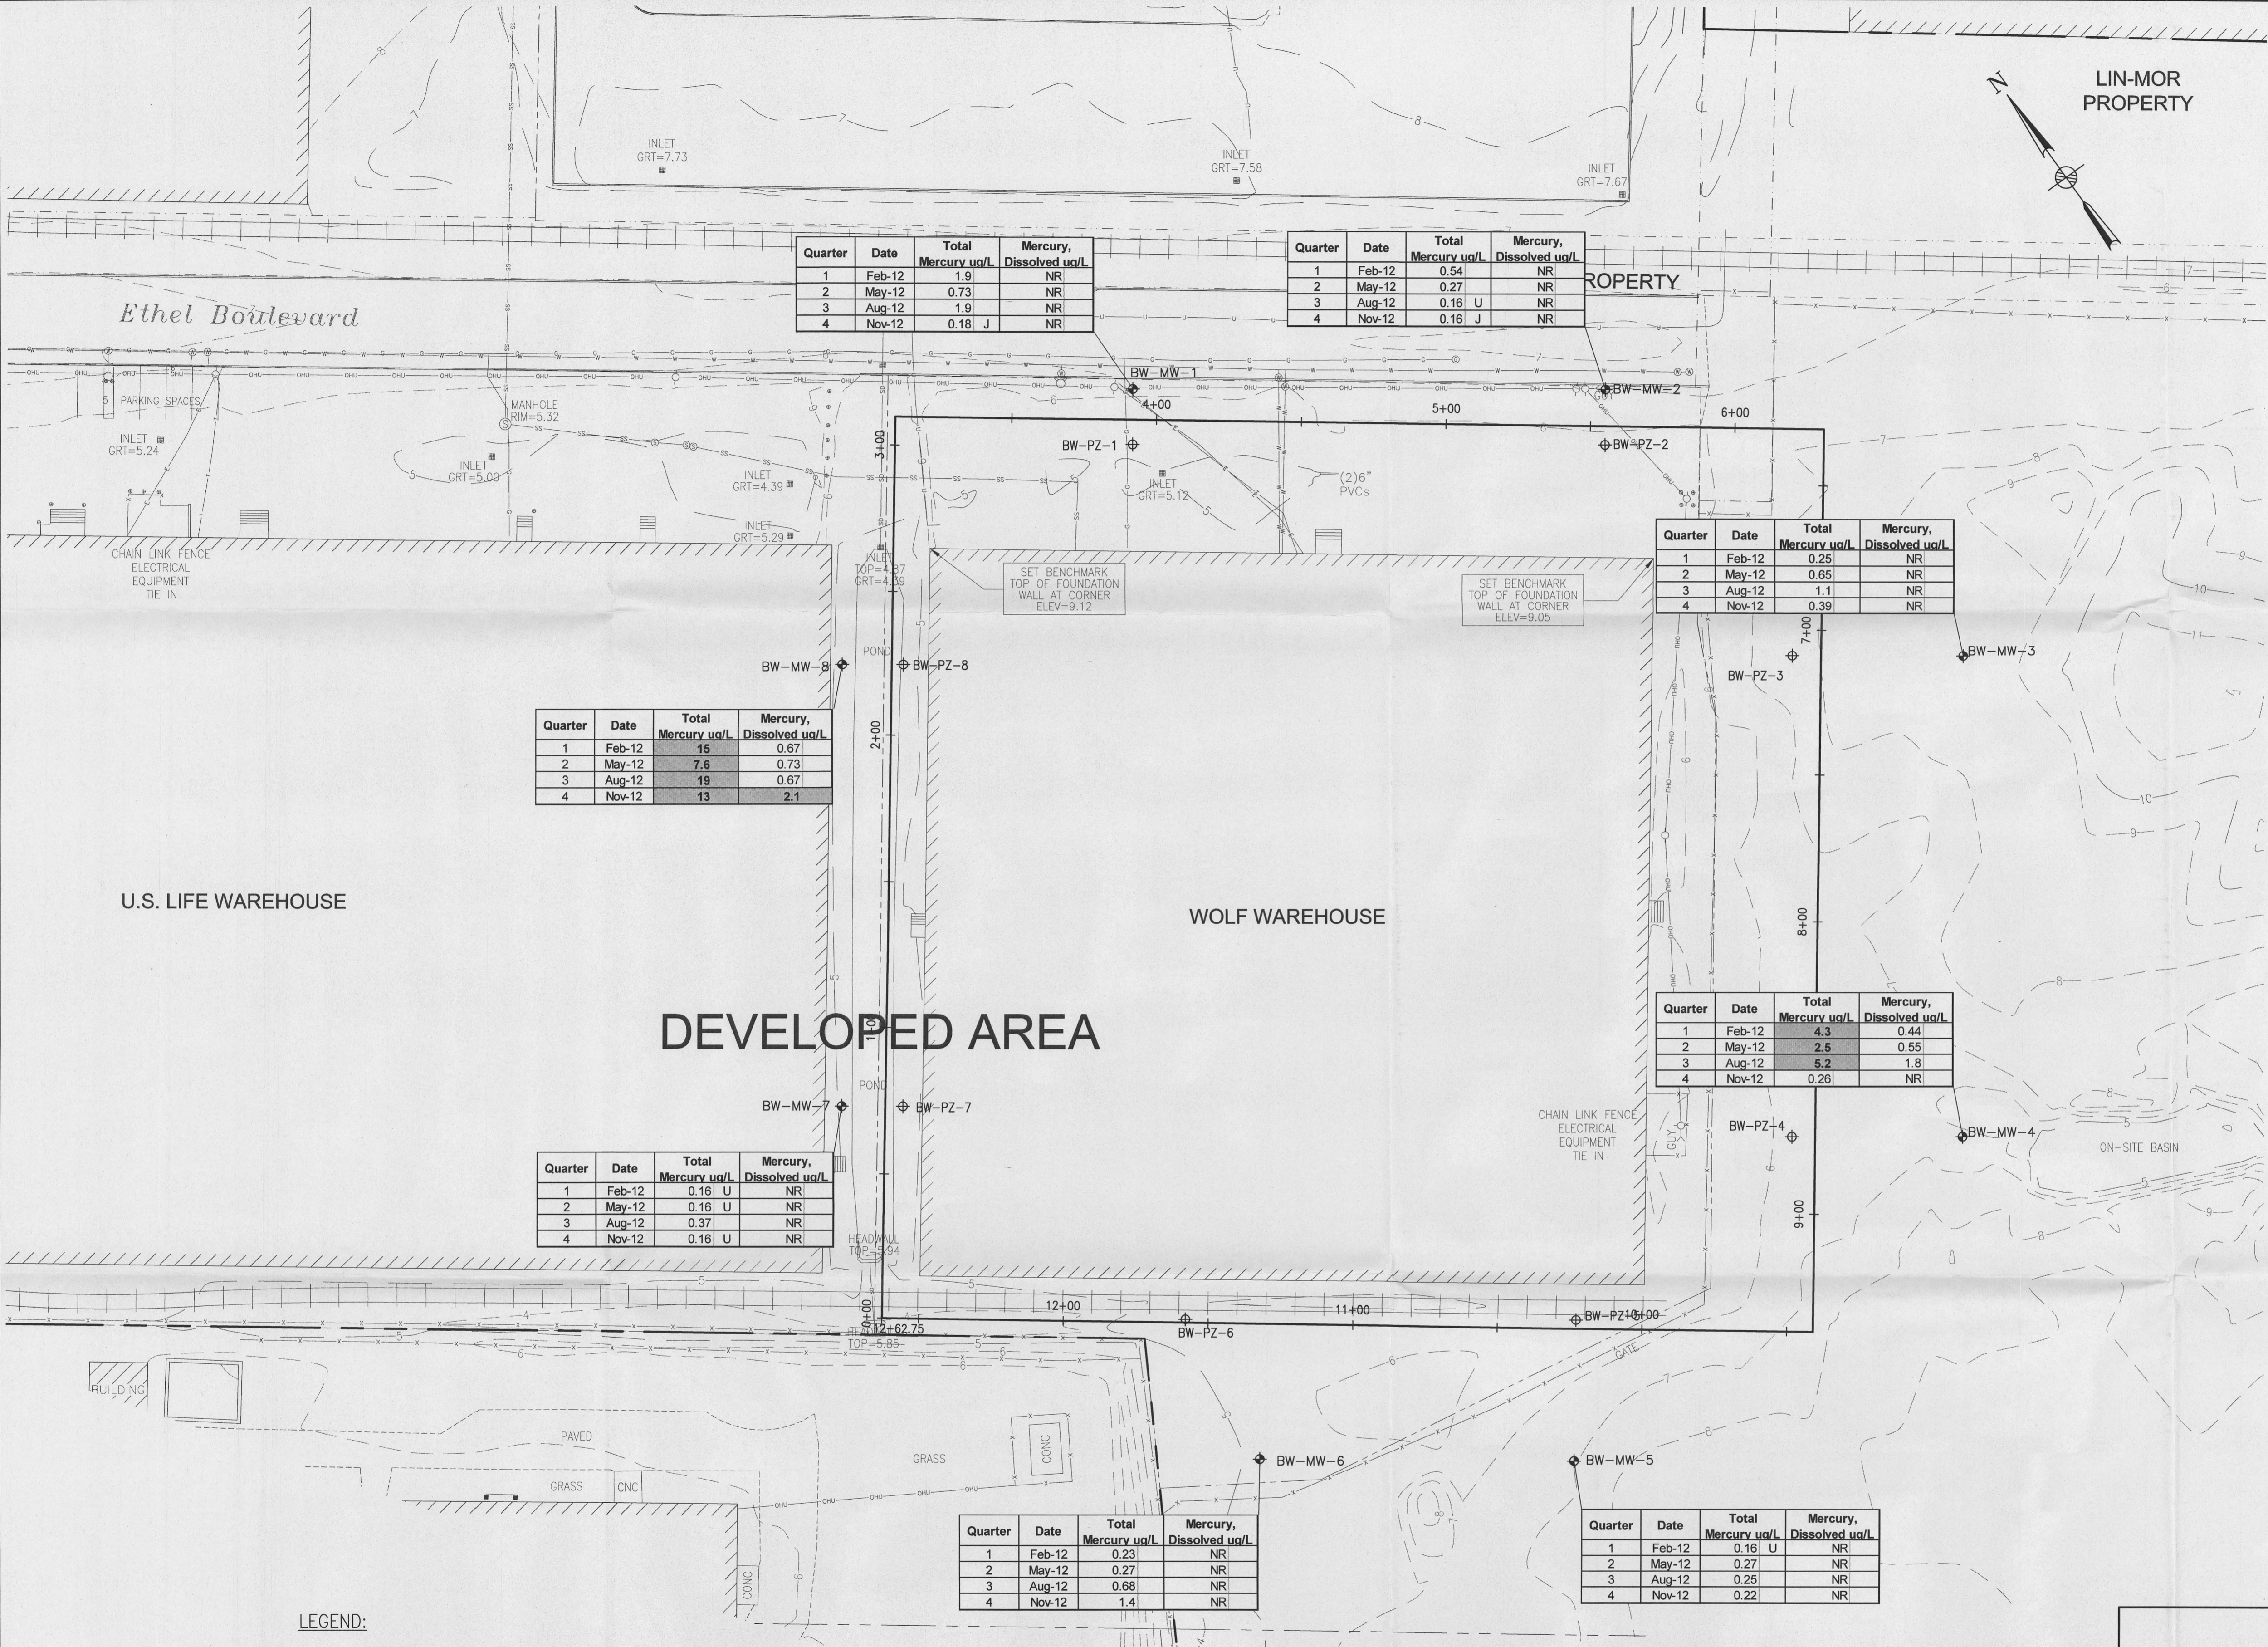
Figure 4 – Vertical Barrier Wall Effectiveness Monitoring and Sampling Plan

Vertical Barrier Wall Effectiveness Sampling Program		
Monitoring Wells	BW-MW-1	S
	BW-MW-2	S
	BW-MW-3	S
	BW-MW-4	S
	BW-MW-5	S
	BW-MW-6	S
	BW-MW-7	S
	BW-MW-8	S
Piezometers	BW-PZ-1	WL
	BW-PZ-2	WL
	BW-PZ-3	WL
	BW-PZ-4	WL
	BW-PZ-5	WL
	BW-PZ-6	WL
	BW-PZ-7	WL
	BW-PZ-8	WL

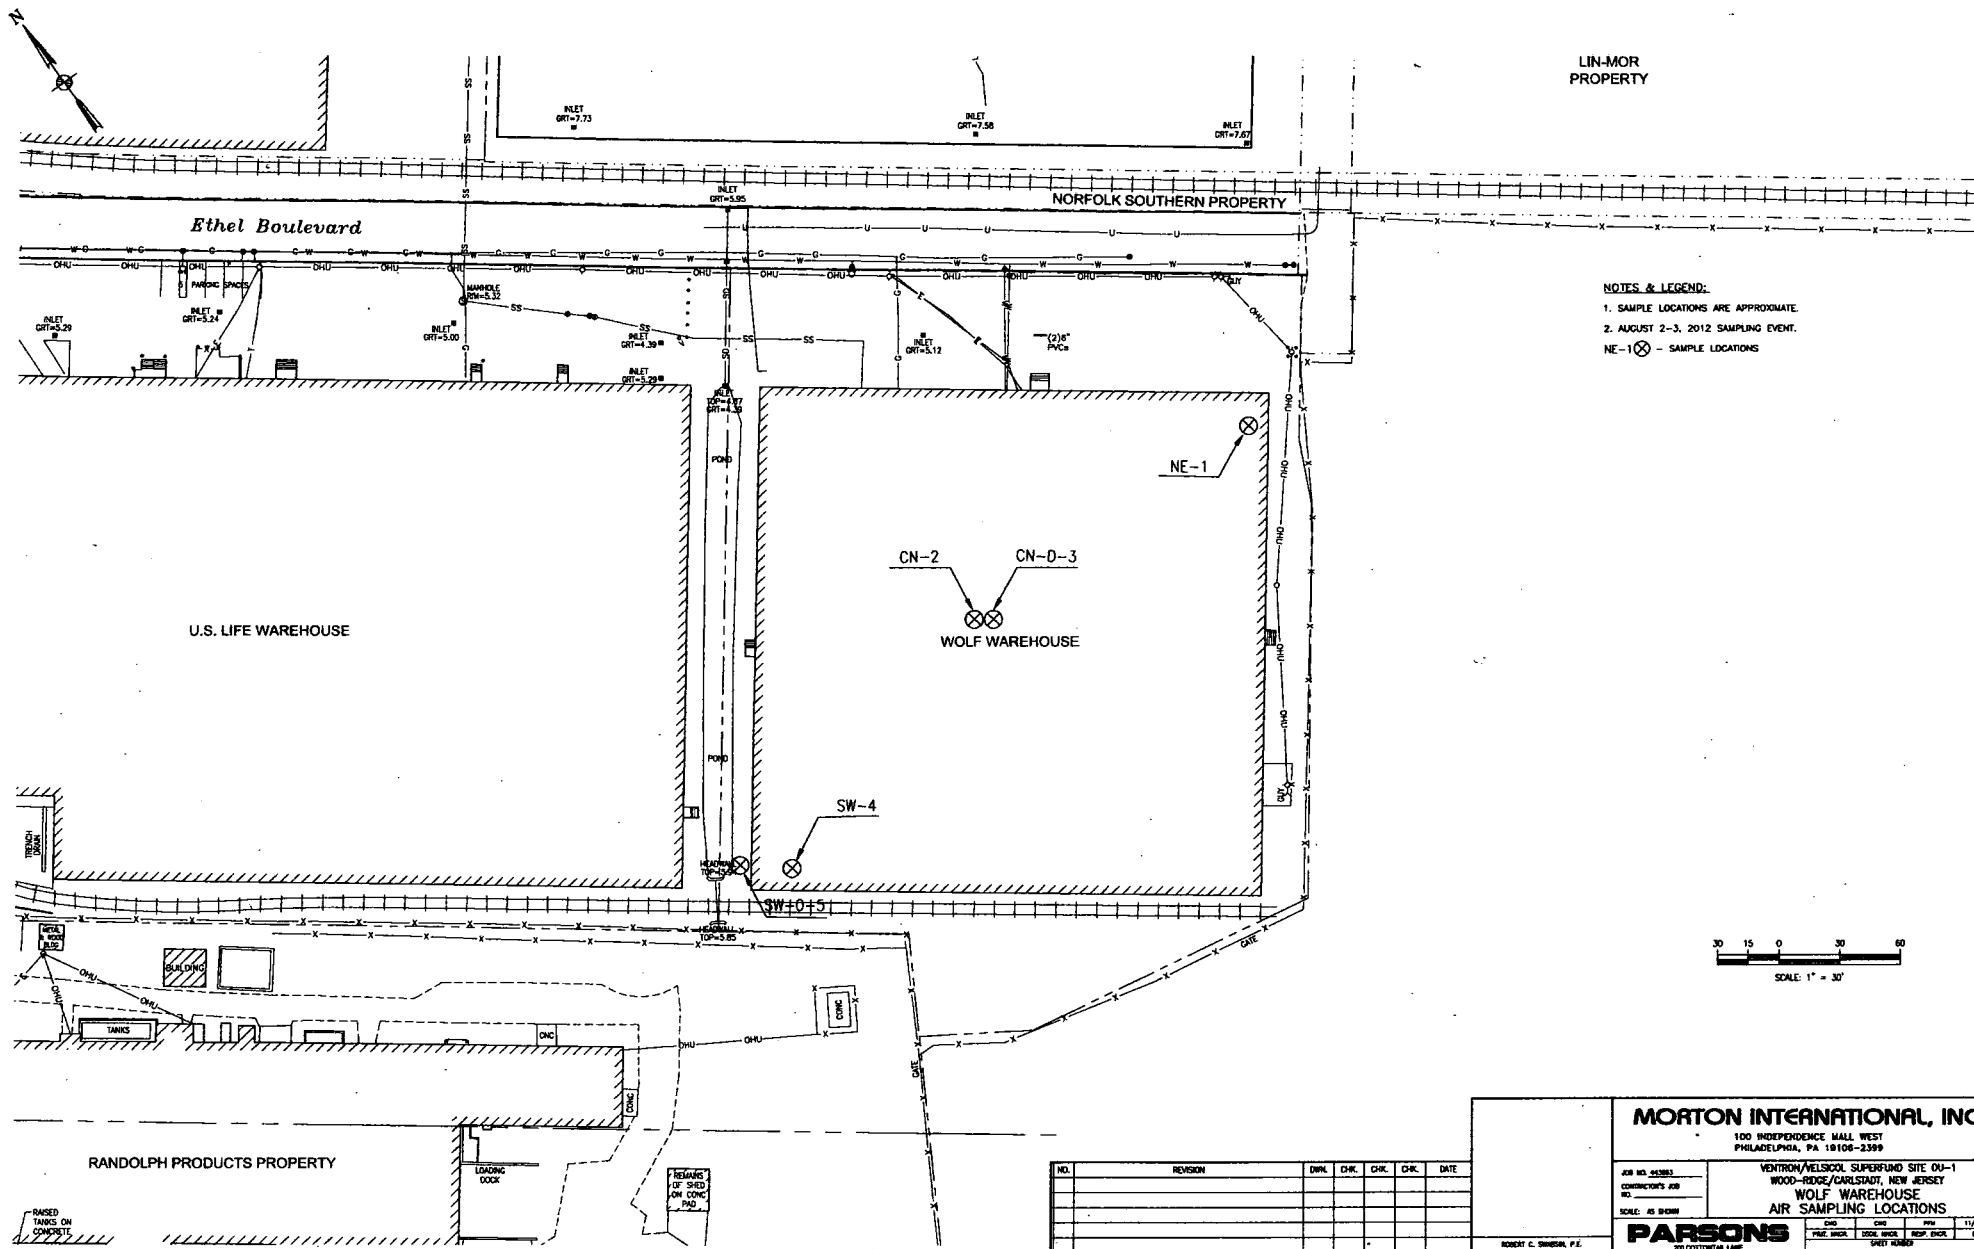
Based on the prior sampling, the building survey, and weather conditions for the sampling period, four sampling locations were selected: three indoor locations and one outdoor. The sample locations are shown on **Figure 1** and were named as follows:

NOTES & LEGEND:
 1. SAMPLE LOCATIONS ARE APPROXIMATE.
 2. AUGUST 2-3, 2012 SAMPLING EVENT.
 NE-1 ⊗ - SAMPLE LOCATIONS
